# ENGINEER'S INSPECTION REPORT

OFFICE OF THE STATE ENGINEER - DIVISION OF WATER RESOURCES - DAM SAFETY BRANCH

DAM NAME: HALE - DWIGHT G T: 150S R: 0650W S: 29 COUNTY: EL PASO DATE OF INSPECTION: 12/7/2017  
DAM ID: 100136 YRComp: 1940 DAM HEIGHT(FT): 13.5 SPILLWAY WIDTH(FT): 82.0 PREVIOUS INSPECTION: 9/28/1987  
CLASS: Low hazard DAM LENGTH(FT): 600.0 SPILLWAY CAPACITY(CFS): 1062.0 NORMAL STORAGE (AF): 6.0  
DIV: 2 WD: 10 CRESTWIDTH(FT): 10.0 FREEBOARD (FT): 4.0 SURFACE AREA(AC): 2.0  
EAP: Not Required CRESTELEV(FT): 5600.0 DRAINAGE AREA (AC.): 1050.0 OUTLET INSPECTED:

Hale Dam  
DAMID 100136  
Inspection Photos

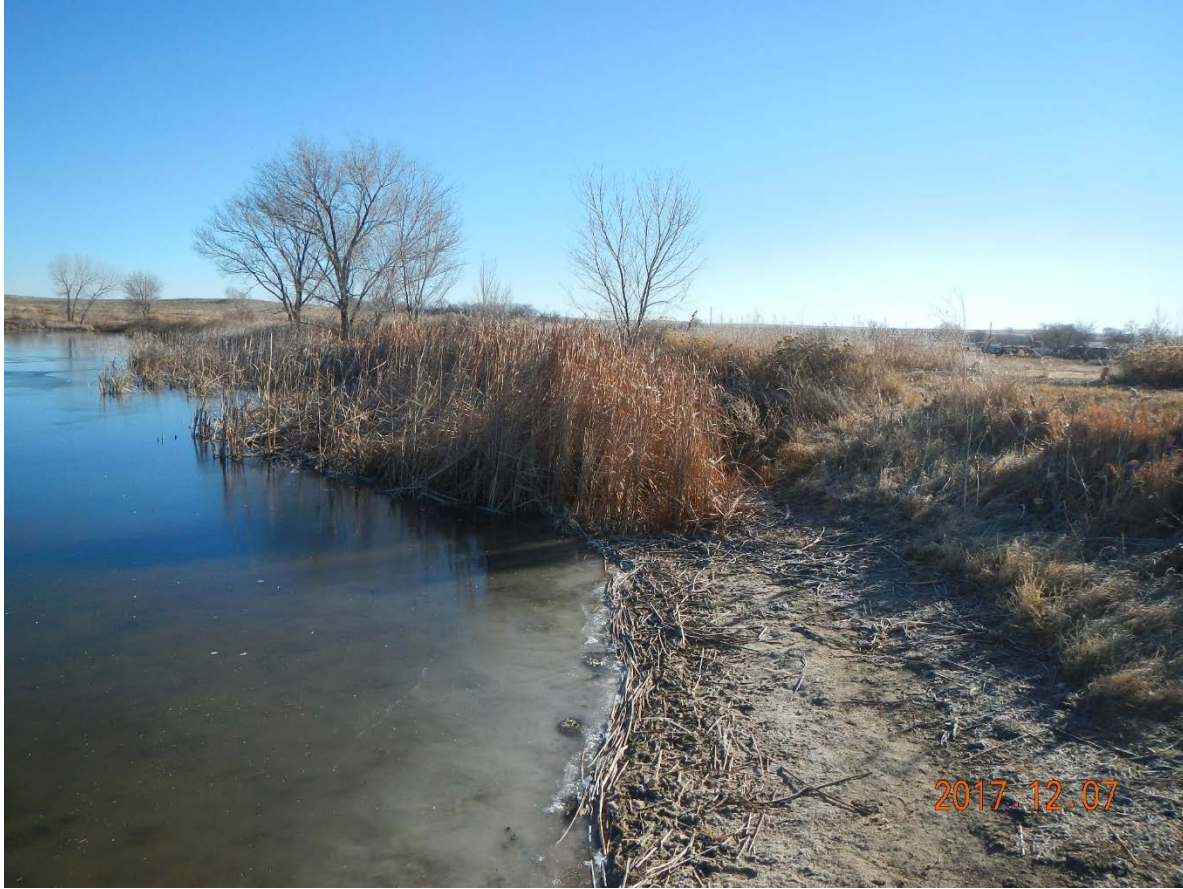
The upstream slope is significantly overgrown with brush and numerous large trees with roots that visibly extend for many tens of feet. The majority of the upstream slope is near vertical due to wave erosion.

01\_Upstream Slope, from right abutment

Slope should be monitored for signs of continued erosion that could affect the stability of the dam. In particular, should observed for signs of cracking on the crest, near the upstream slope. While not an ideal condition, no immediate stability concerns were identified on upstream slope as a whole. (Reference seepage section for concerns associated with previous embankment failure).

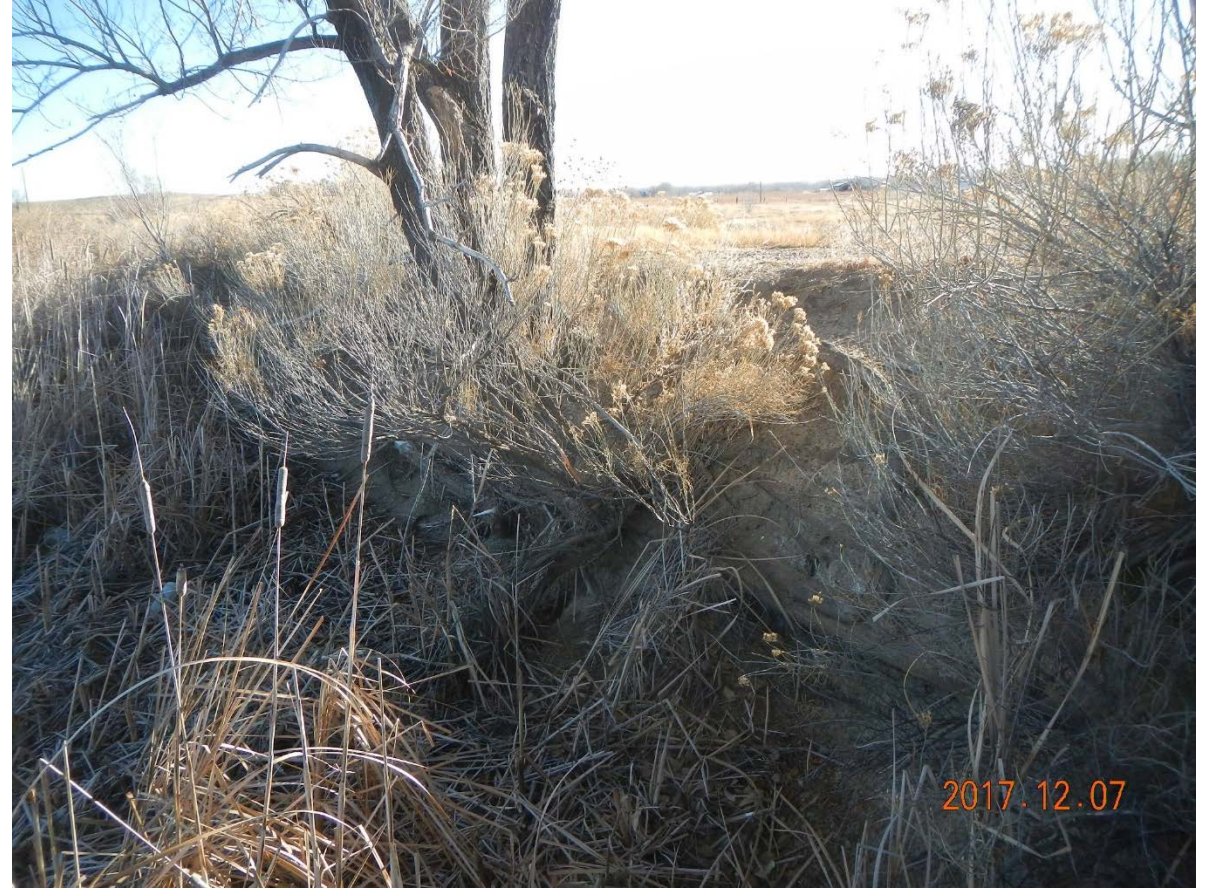
02\_Upstream Slope, trees/roots

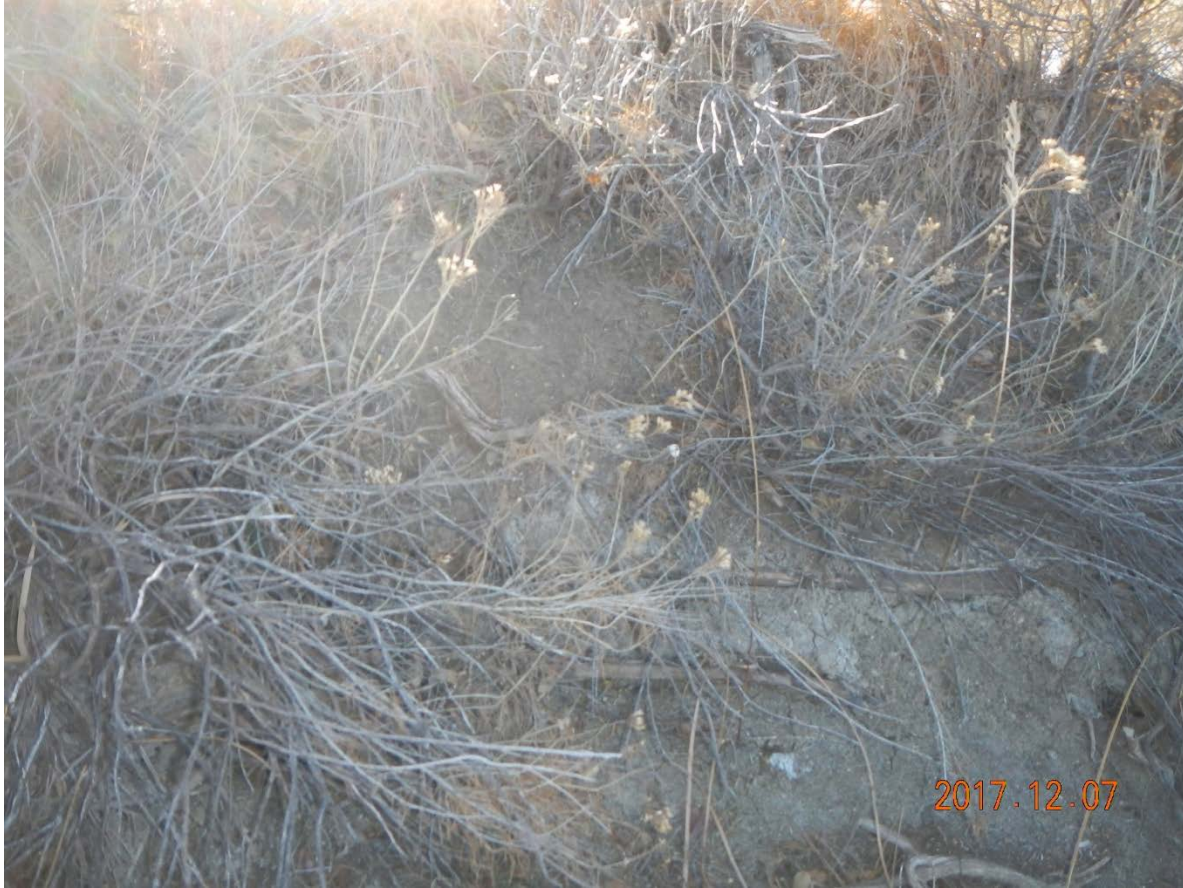
03\_Upstream Slope, roots

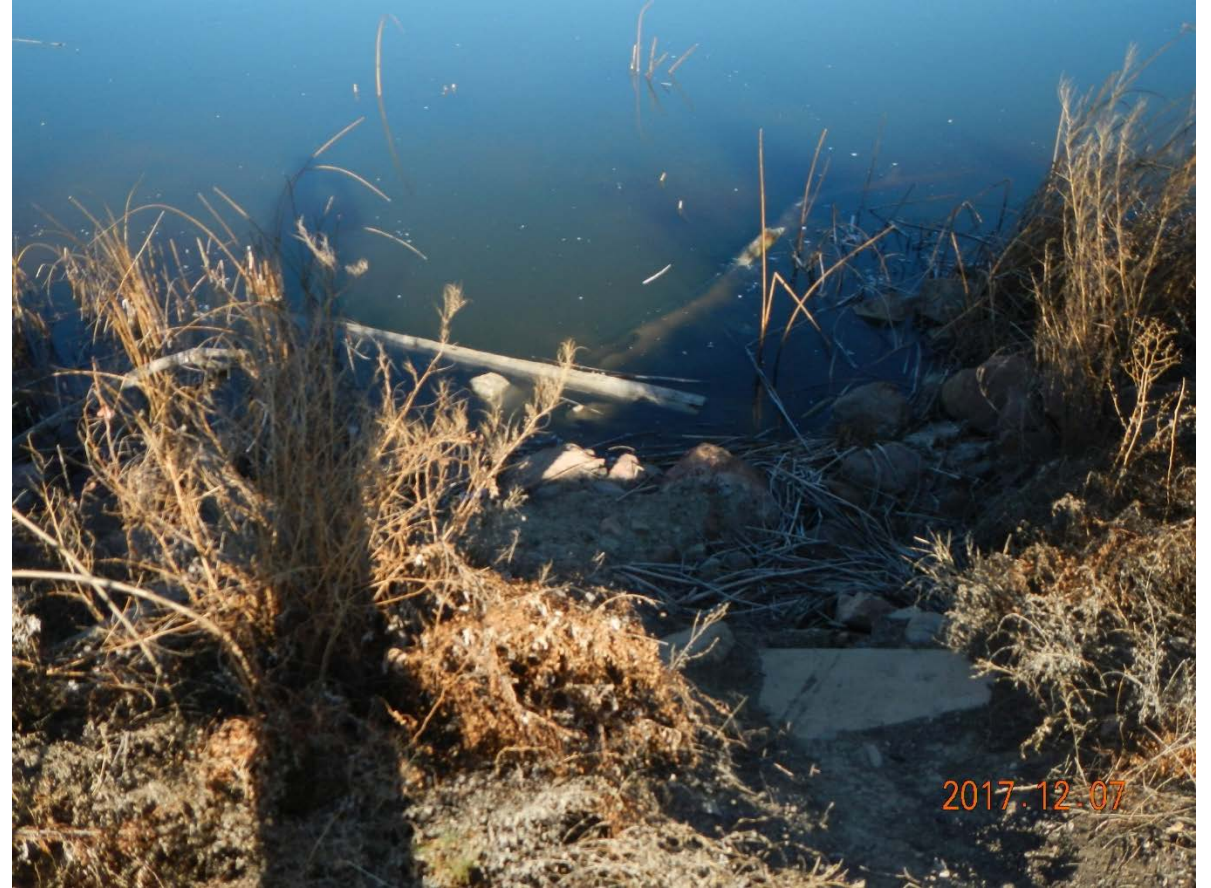
04\_Upstream Slope, previous failure

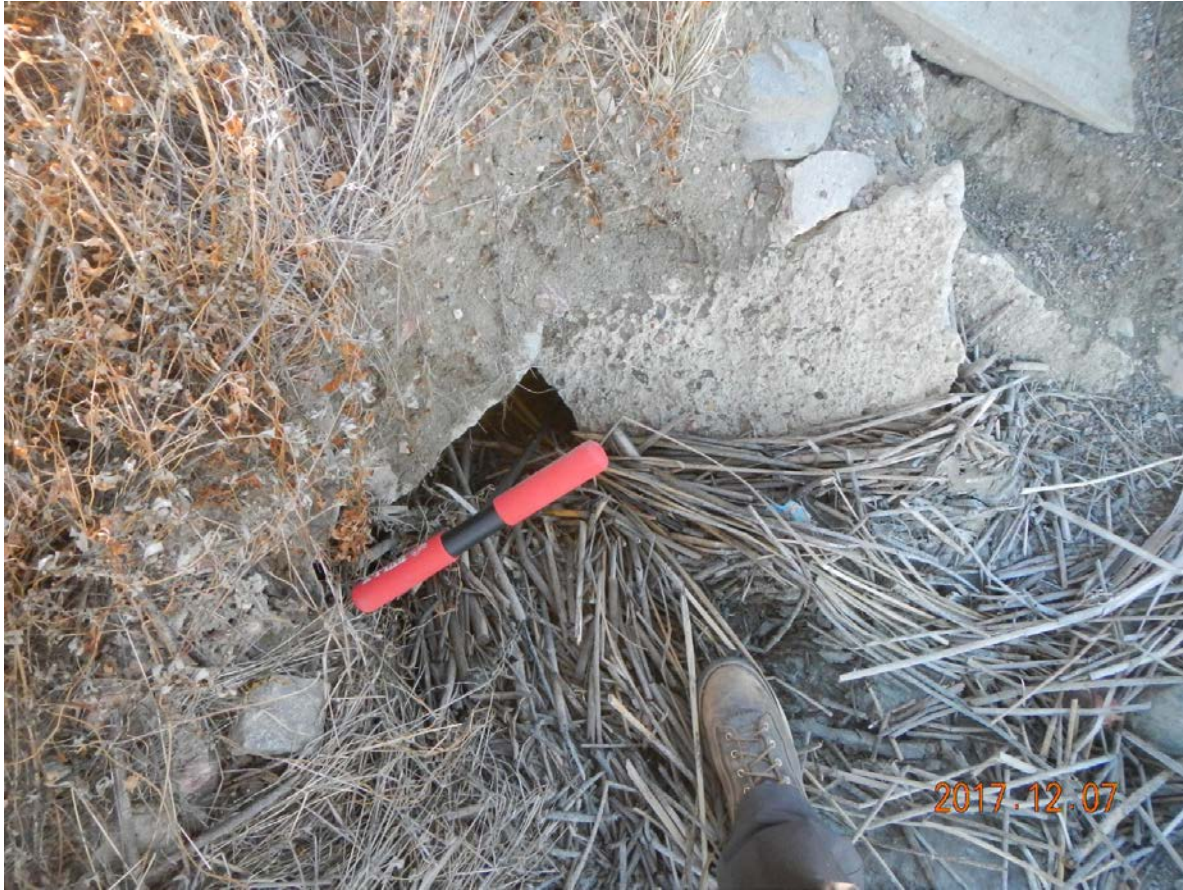
05\_Upstream Slope, previous failure location

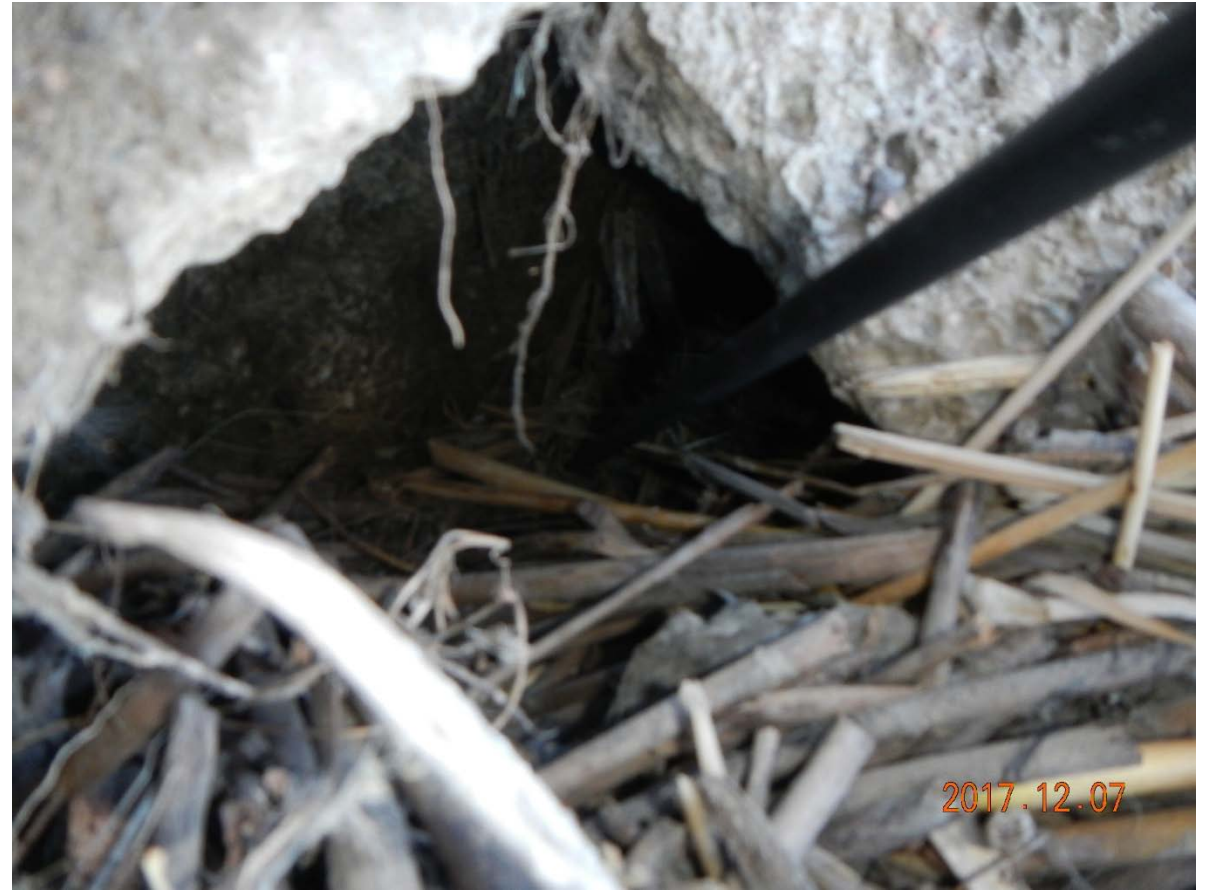
06\_Upstream Slope, previous failure location

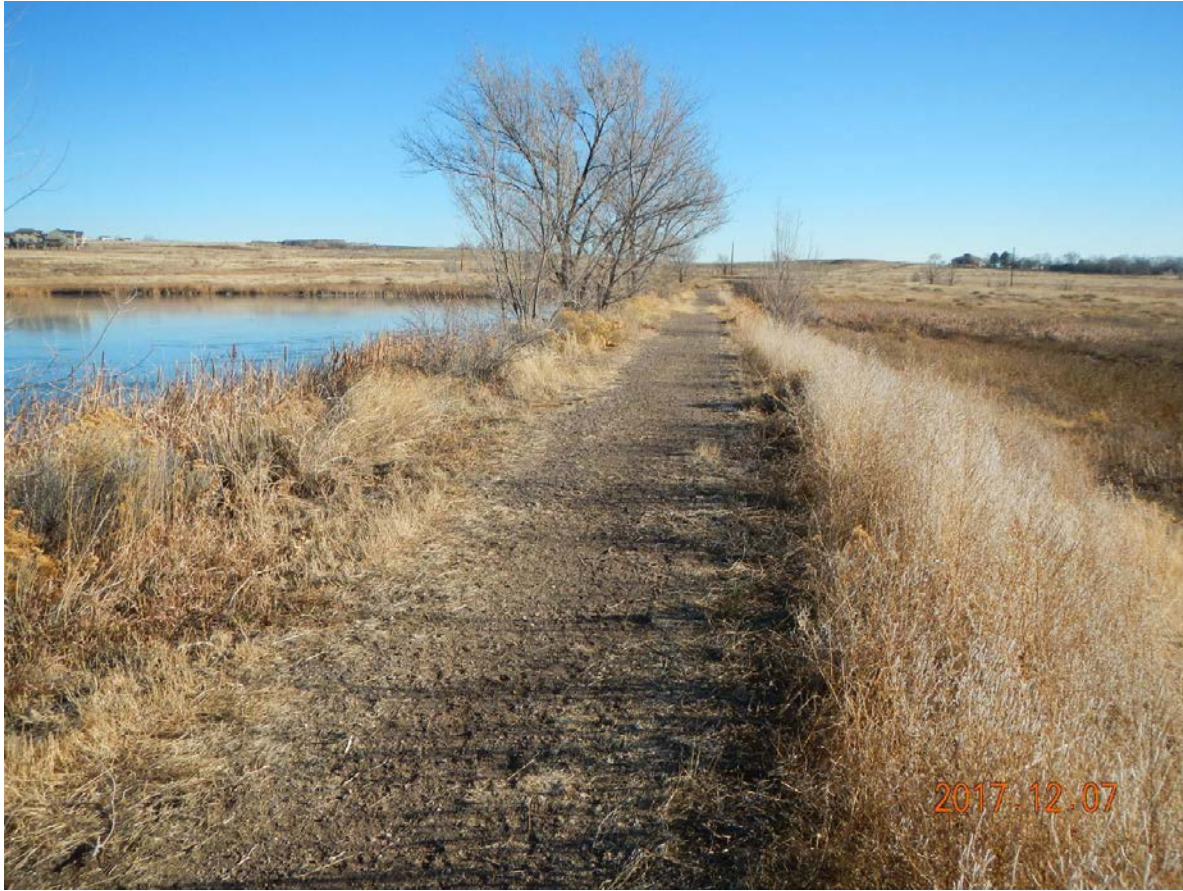
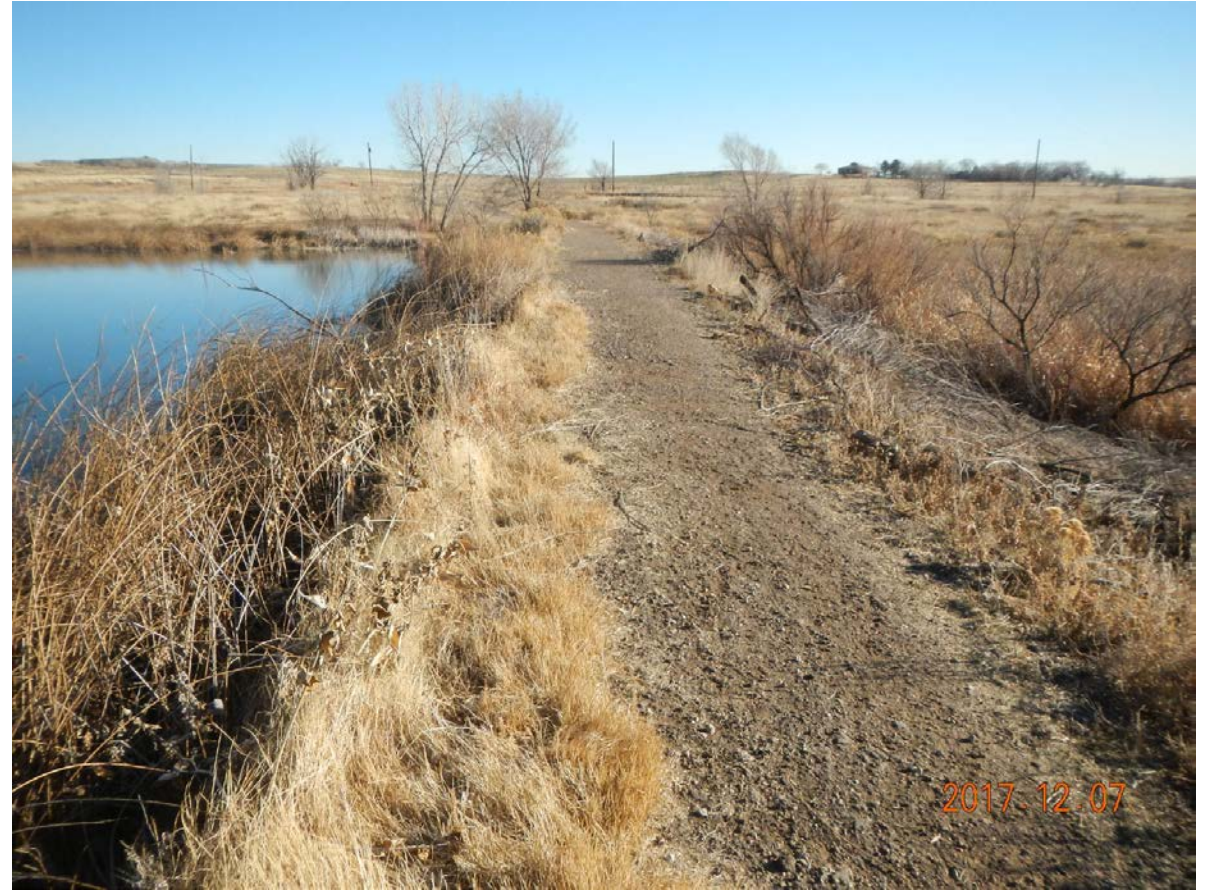
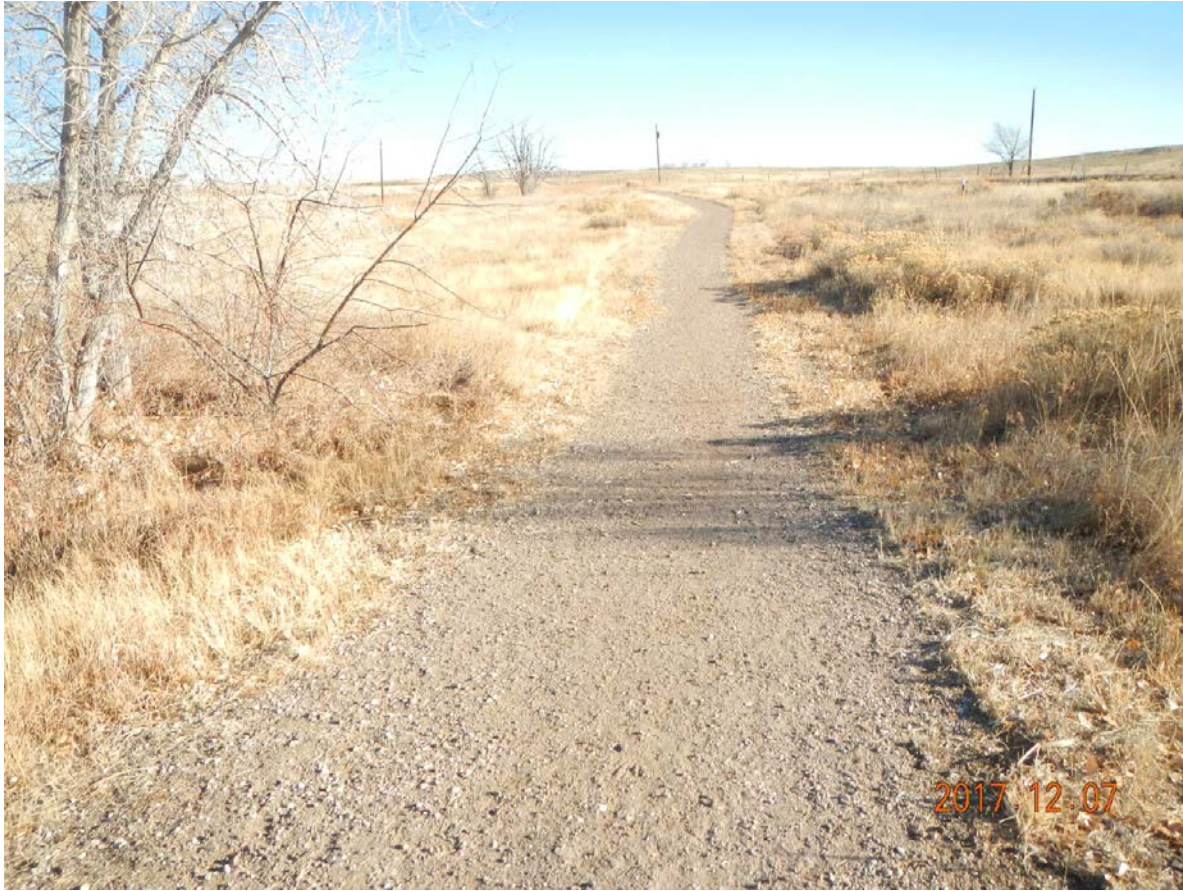
Crest is about 10-ft wide and has a gravel surface. There is a low spot where the dam had previously failed and been repaired towards the left end of the dam.

07\_Dam Crest

The area of the previous failure should be closely observed for continued settlement or sloughing on downstream slope around pipe.

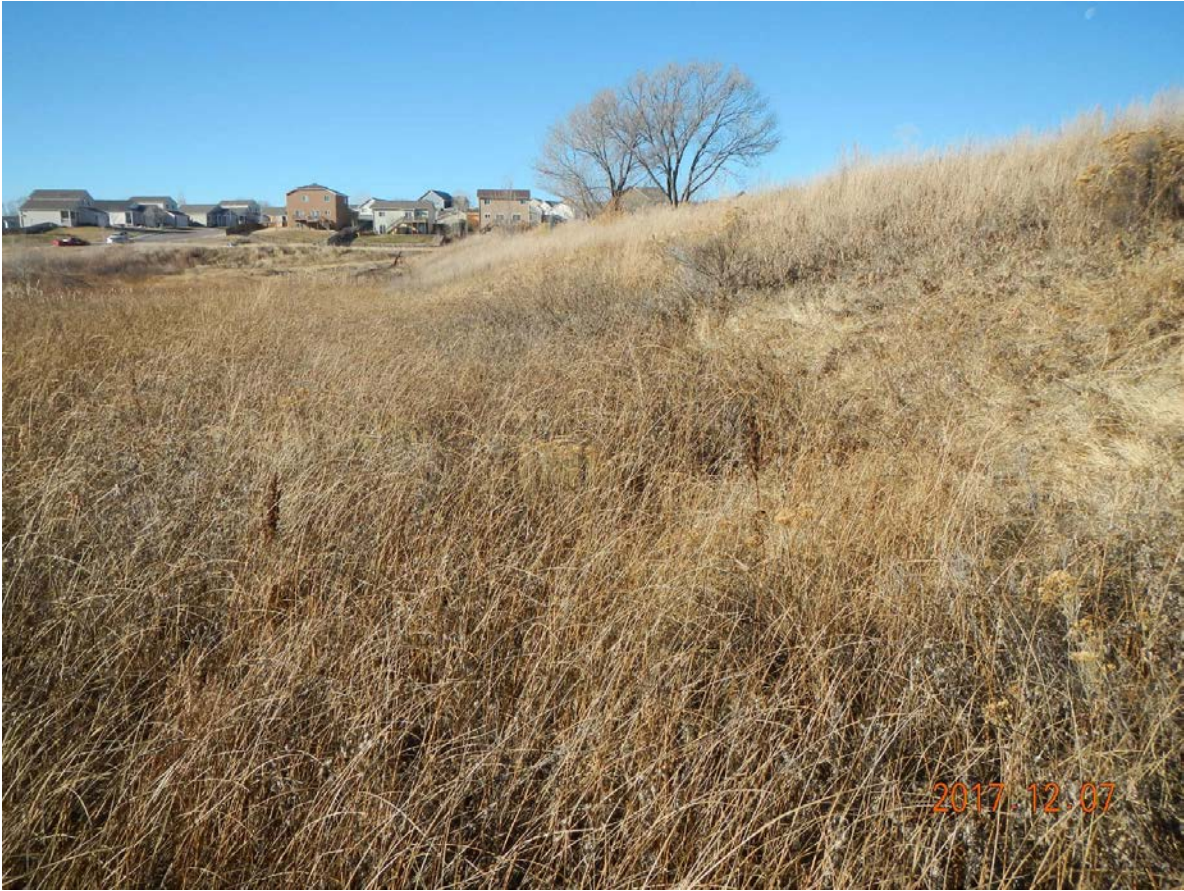
The downstream slope is generally about 2.5H:1V with a covering of weeds. Overall, the slope is fairly uniform. The major point of concern would be the area of the previous failure (location shown in attached site location Map). This area was repaired with an about 12-inch diameter ADS plastic pipe that allows flows to enter from the reservoir (although the upstream intake could not be located). On the downstream side, the pipe enters into the downstream toe. The slopes are near vertical around the pipe and there is concrete rubble used as backfill around the pipe. No cloudy seepage was observed.

10\_Downstream Slope, looking right at central portion

The area of the previous failure should be monitored regularly for signs of increasing seepage, or progressively steepening slopes around the ADS pipe. If there was not a plan to construct a new embankment in the works and planned relatively soon, this area would require full removal of the ADS pipe, and proper repair/compaction of the previously filled zone. If any signs of increased seepage, cloudy seepage, or progressive slope failures are observed prior to the new dam construction, it will be required to lower the reservoir and properly repair this area.

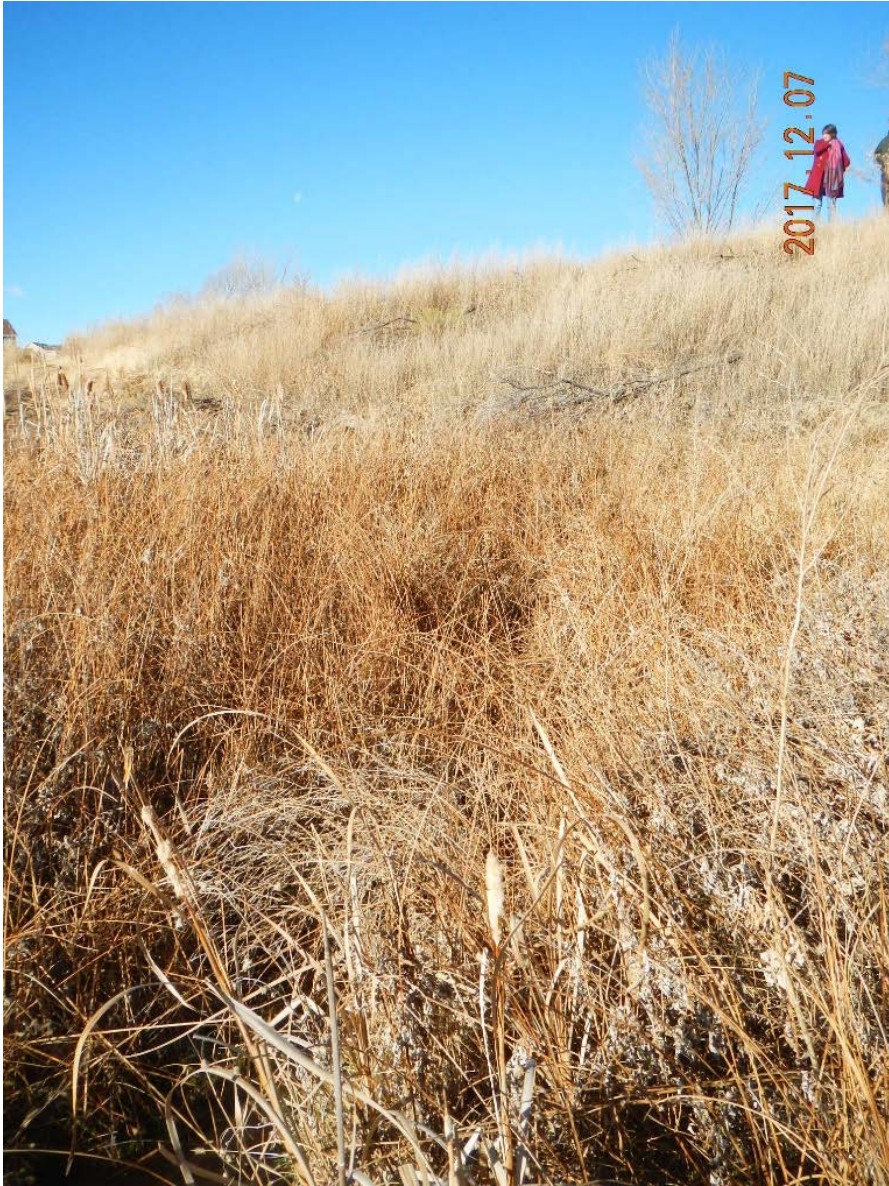
11\_Downstream Slope, above old outlet

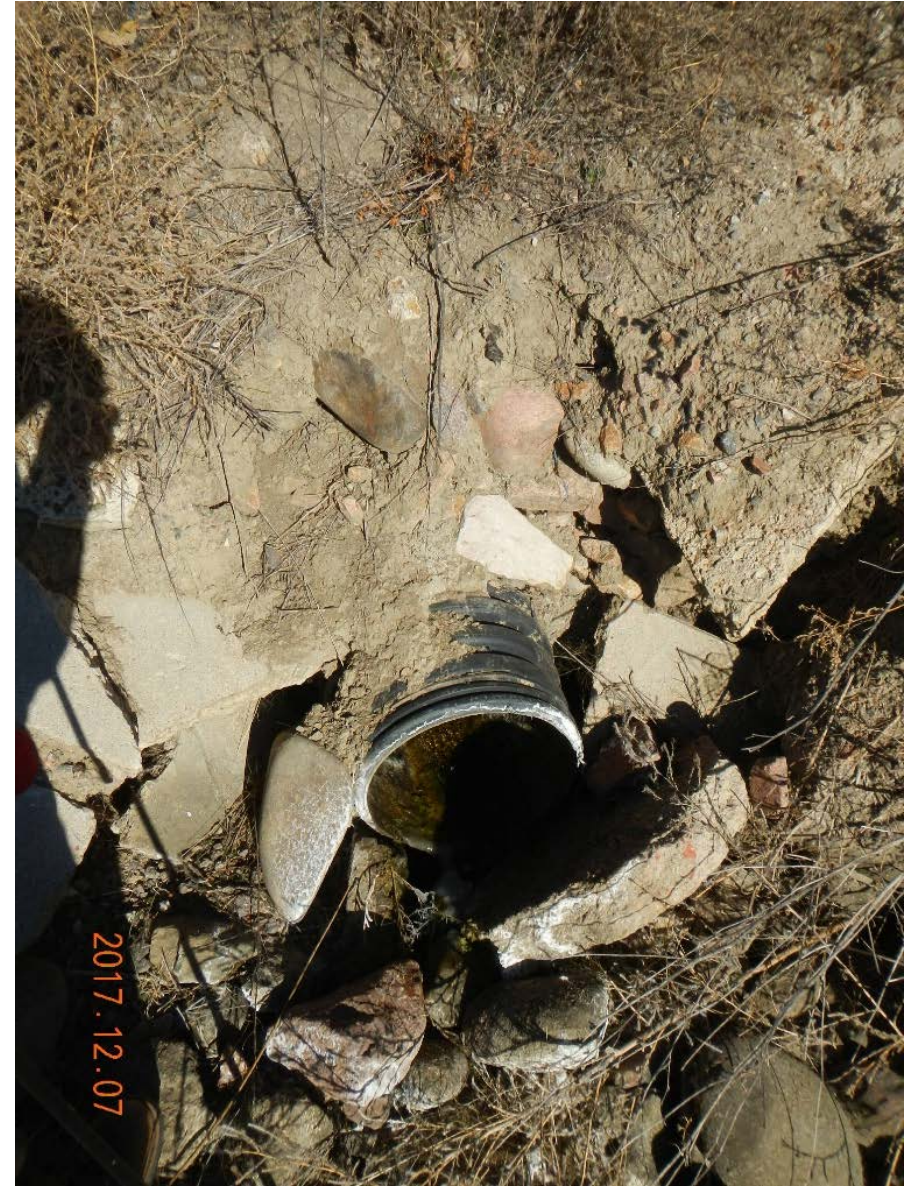
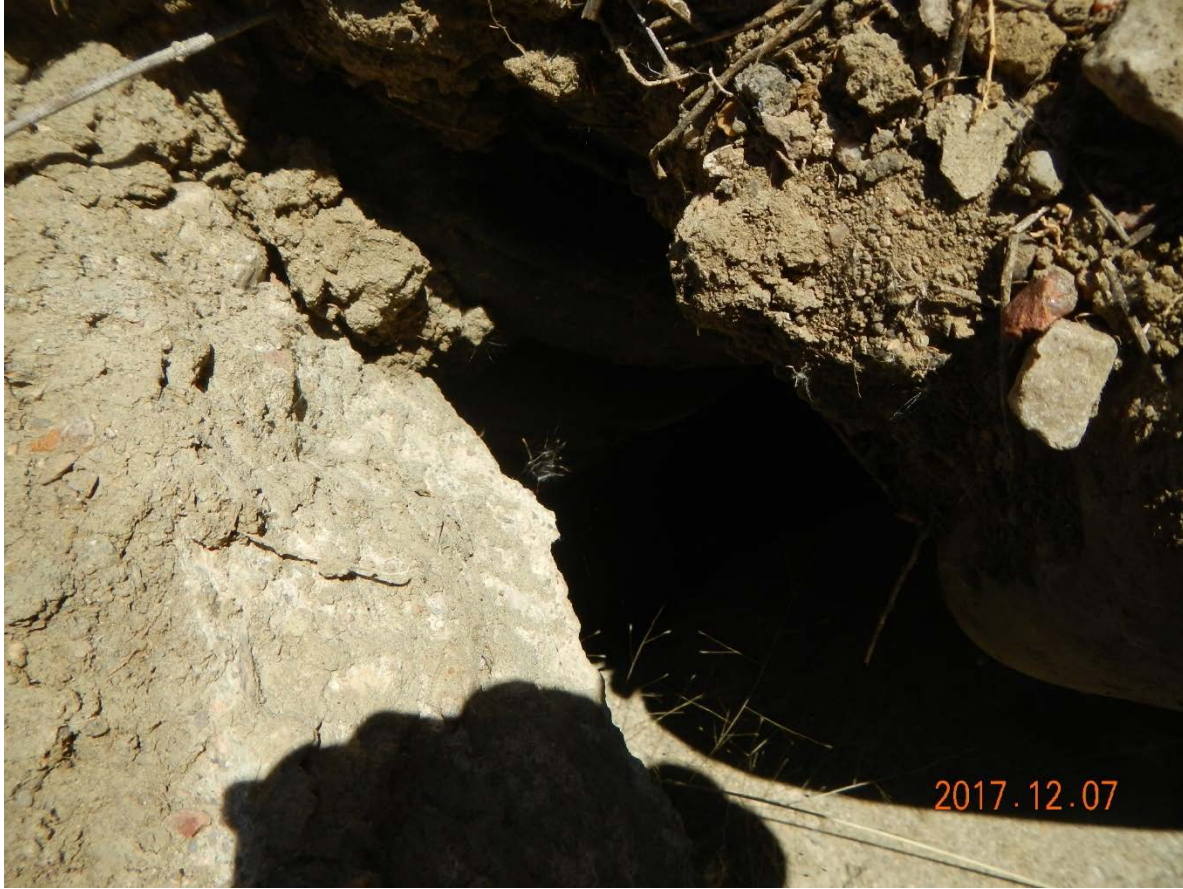
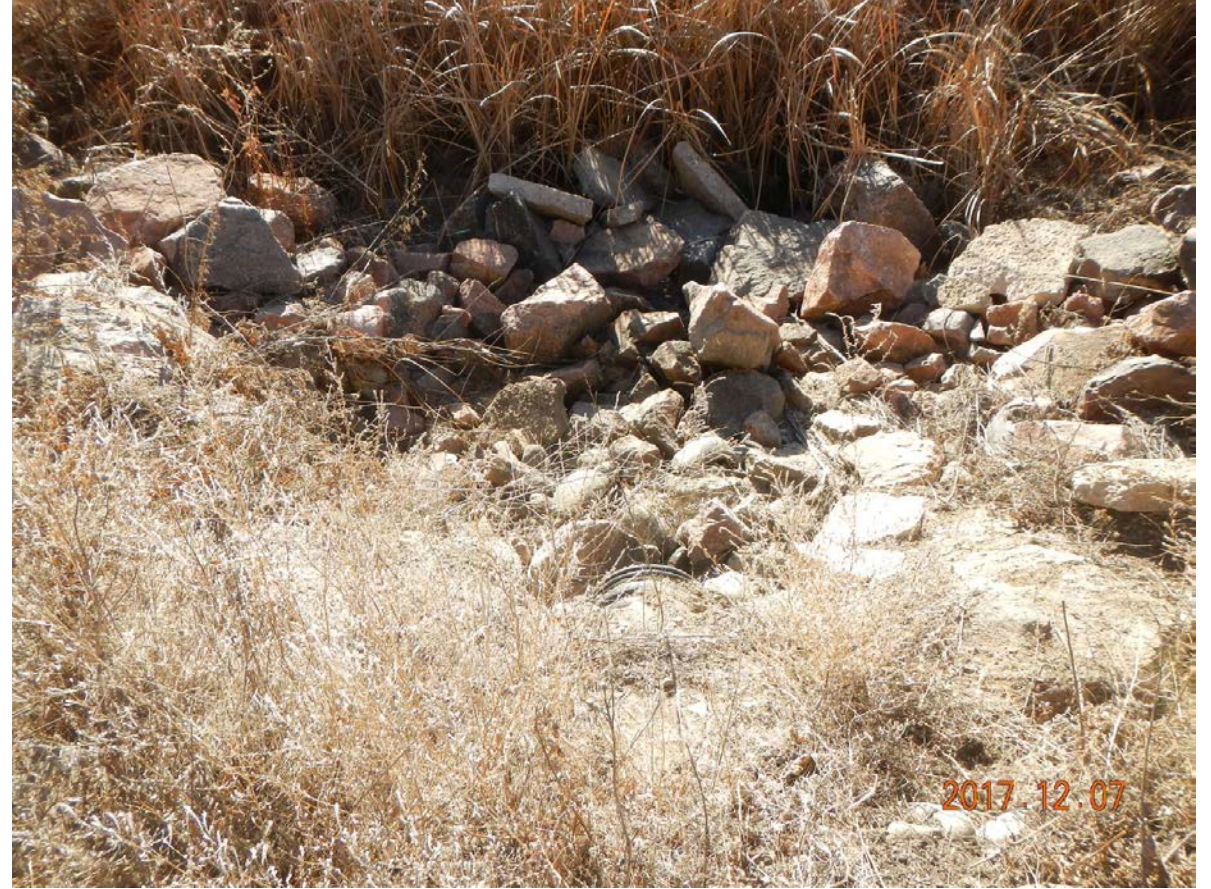
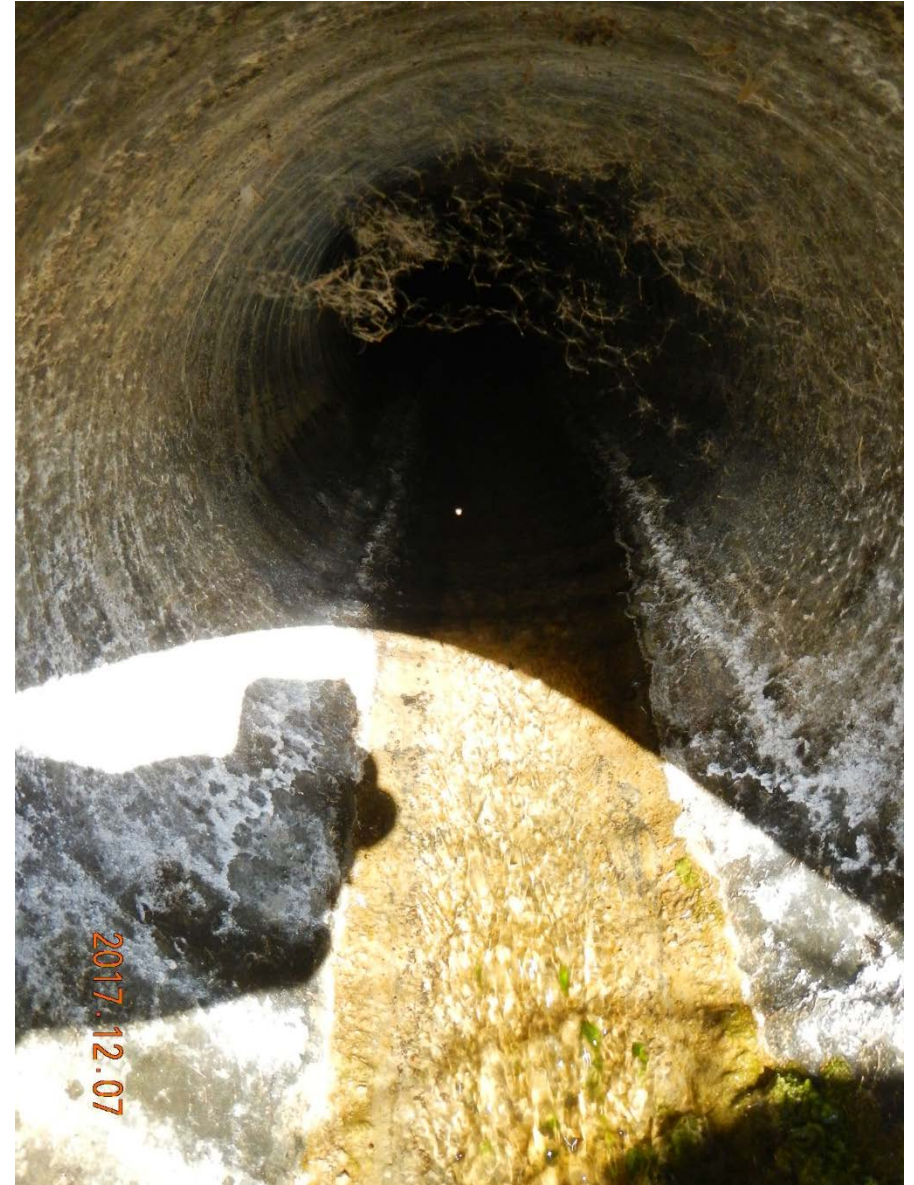
1. Seepage area 1 already described as pipe through at area of old embankment failure. This seepage disseminates into the downstream toe area from the pipe and is estimated to be about 10 to 20 gpm. The entrance to the pipe should be located, if practical.

12\_Seepage, previous failure

**Key monitoring is located at the previous dam failure location. Any signs of increasing seepage, cloudy seepage, or active/progressive slope movement would initiate need to remove ADS black pipe and properly compact/repair this area interim to new construction. Therefore, it is considered important for the owner to visually inspect this area on a routine basis.**

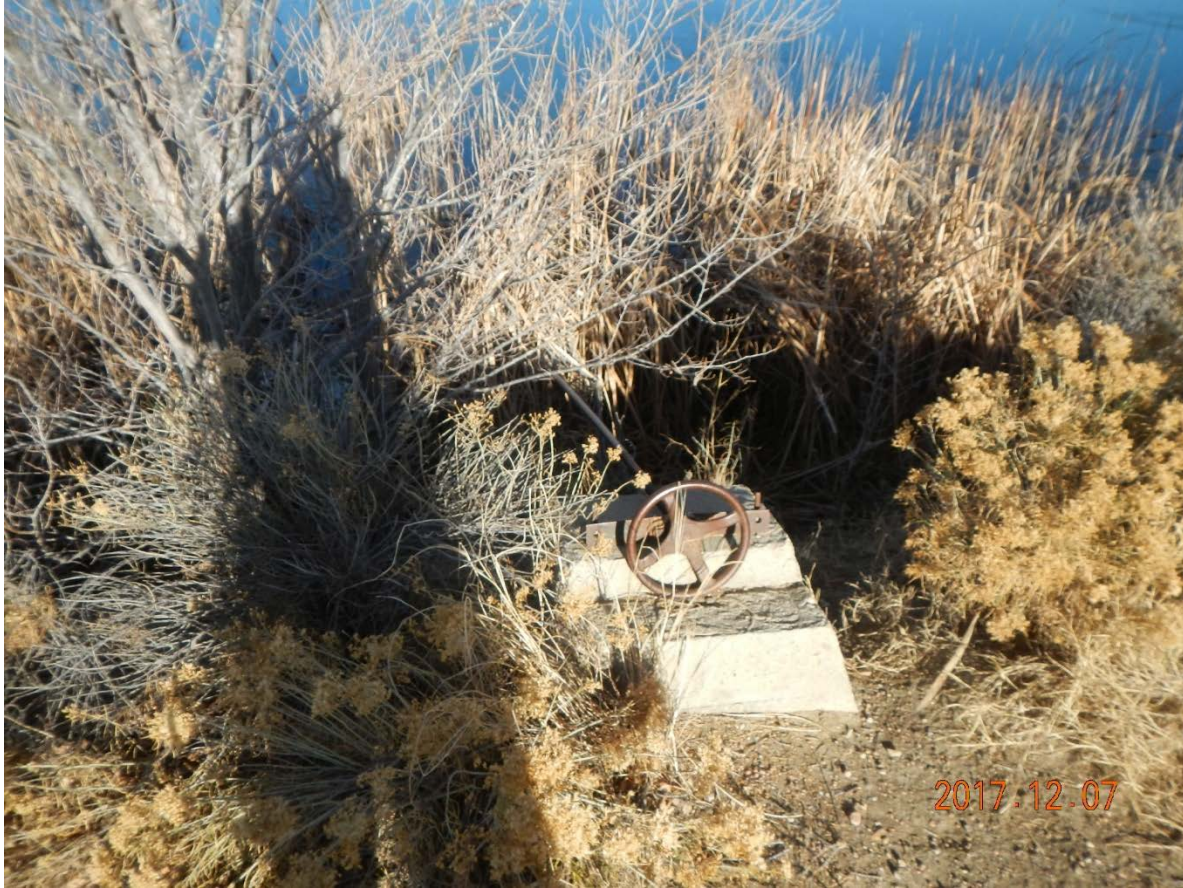
There is remnants of an old outlet near the right-central portion of the dam. An inoperable wheel/stem is on the upstream slope and the concrete headwall at the discharge downstream was located amongst thick cattails. There is no effective outlet for this structure. If a drawdown were planned/required, it would need to be pumped down.

15\_Outlet, old operator

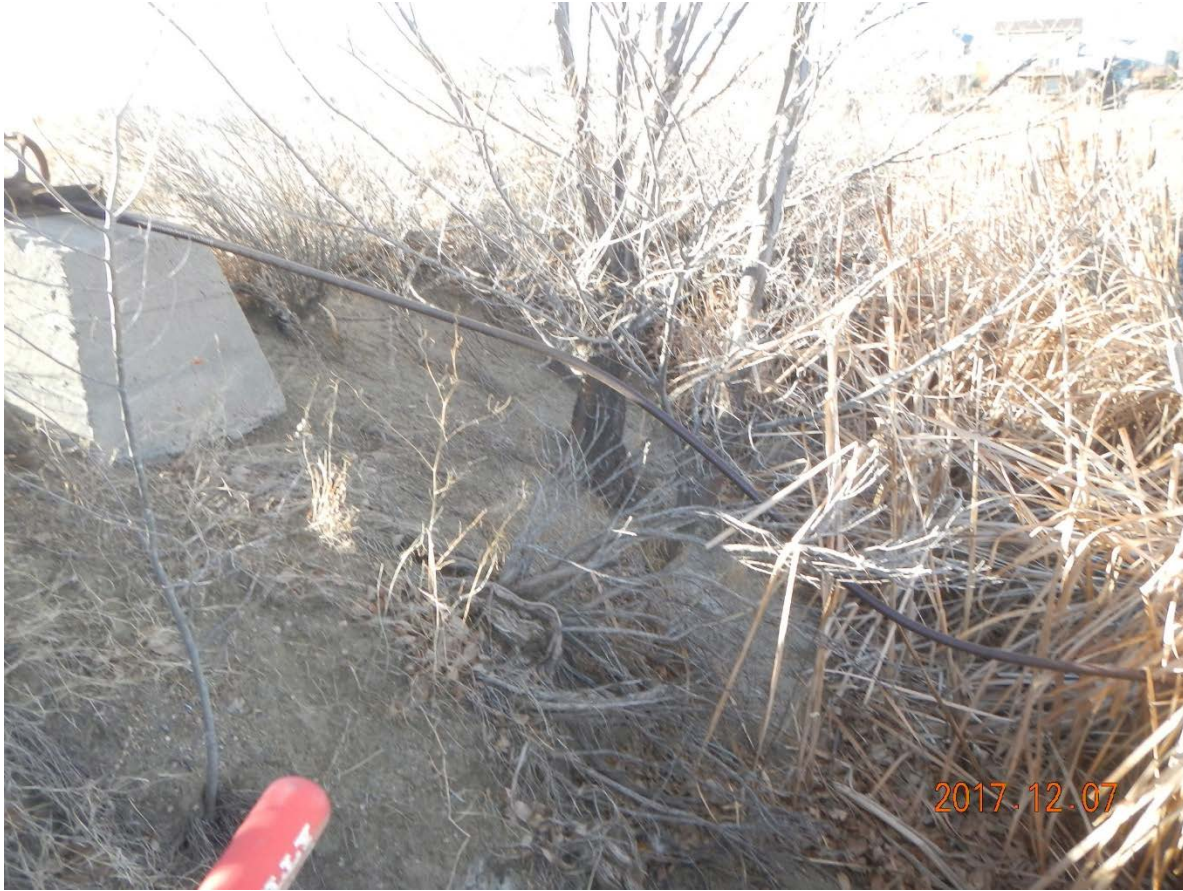
17\_Outlet, operator stem

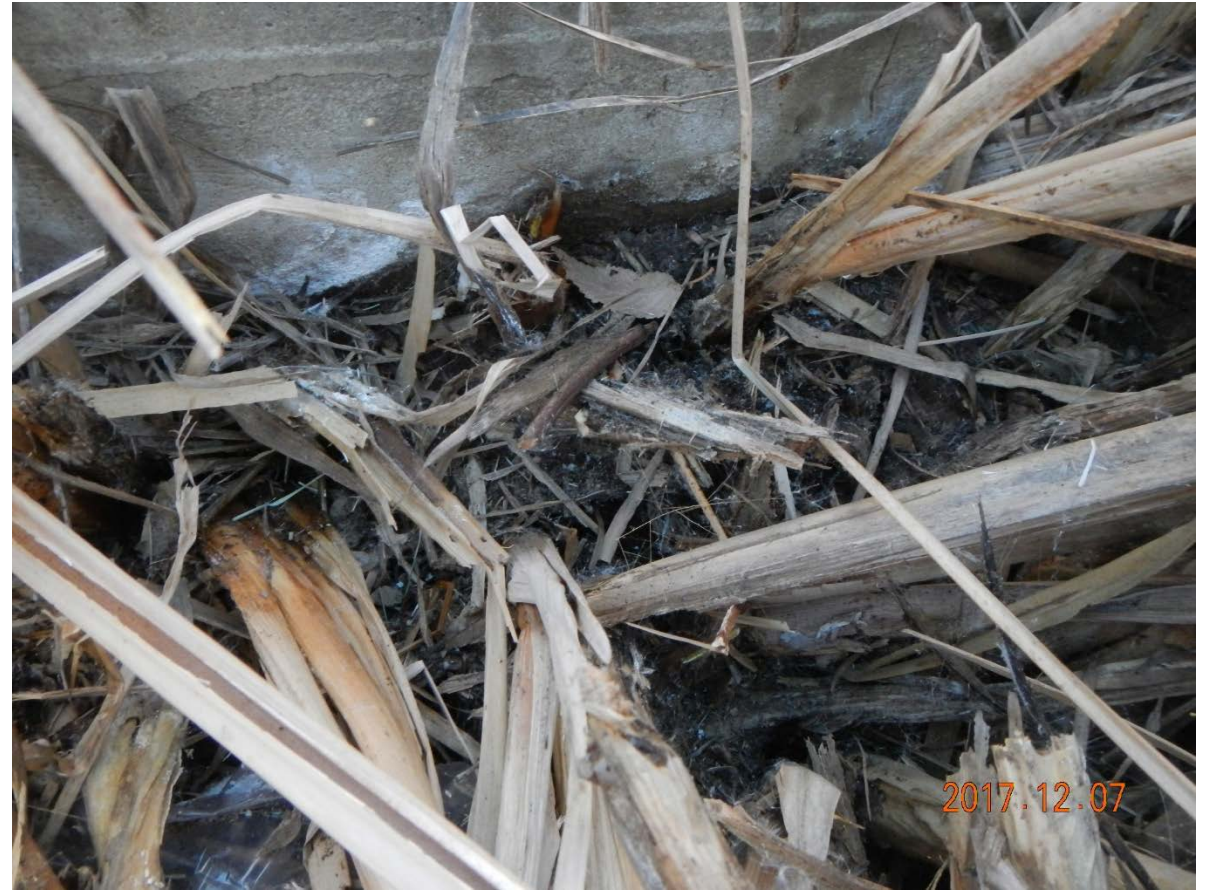
18\_Outlet, old discharge point concrete

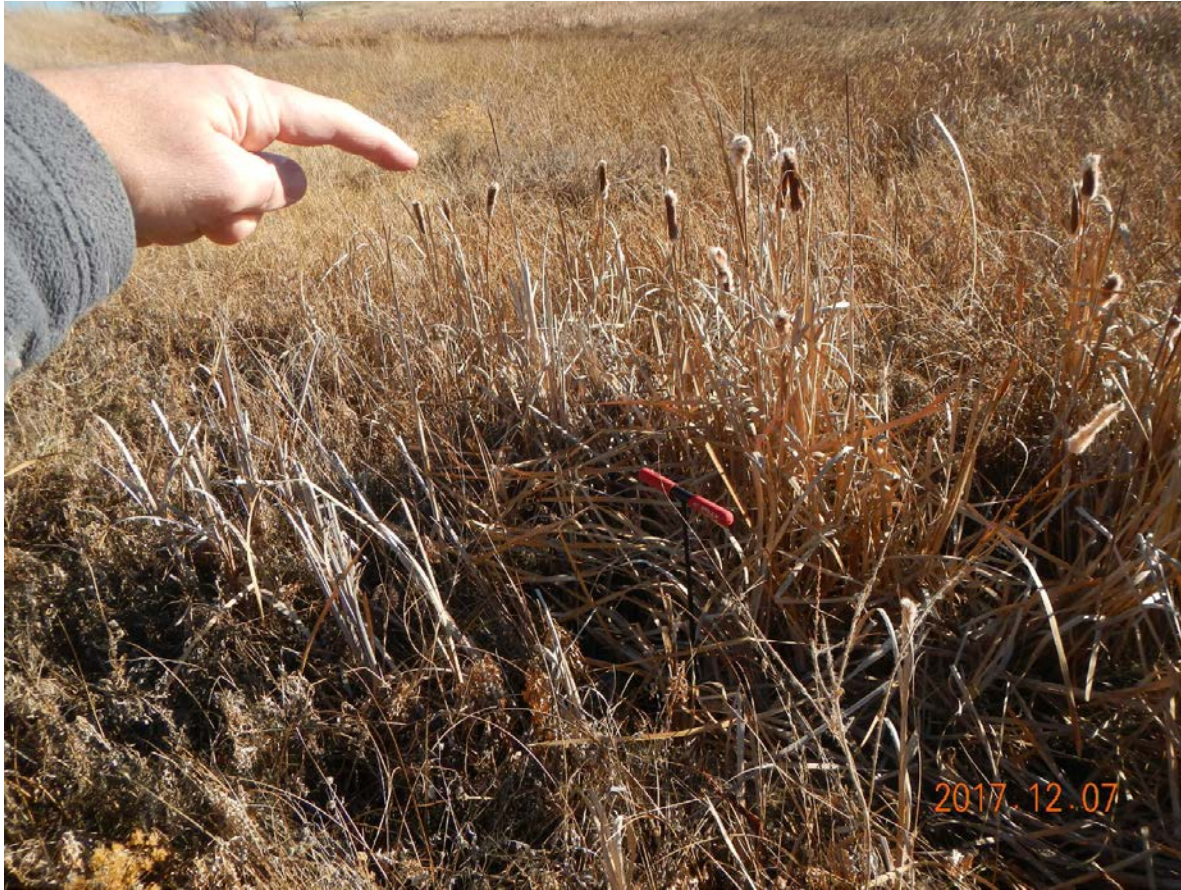
2. Seepage area 2 is located near the old outlet pipe with the inoperable outlet wheel. There is standing water and an incised channel about 20-ft left of the concrete headwall that the old outlet discharges into at downstream toe. No adverse seepage conditions noted at this location.

19\_Seepage area left of outlet

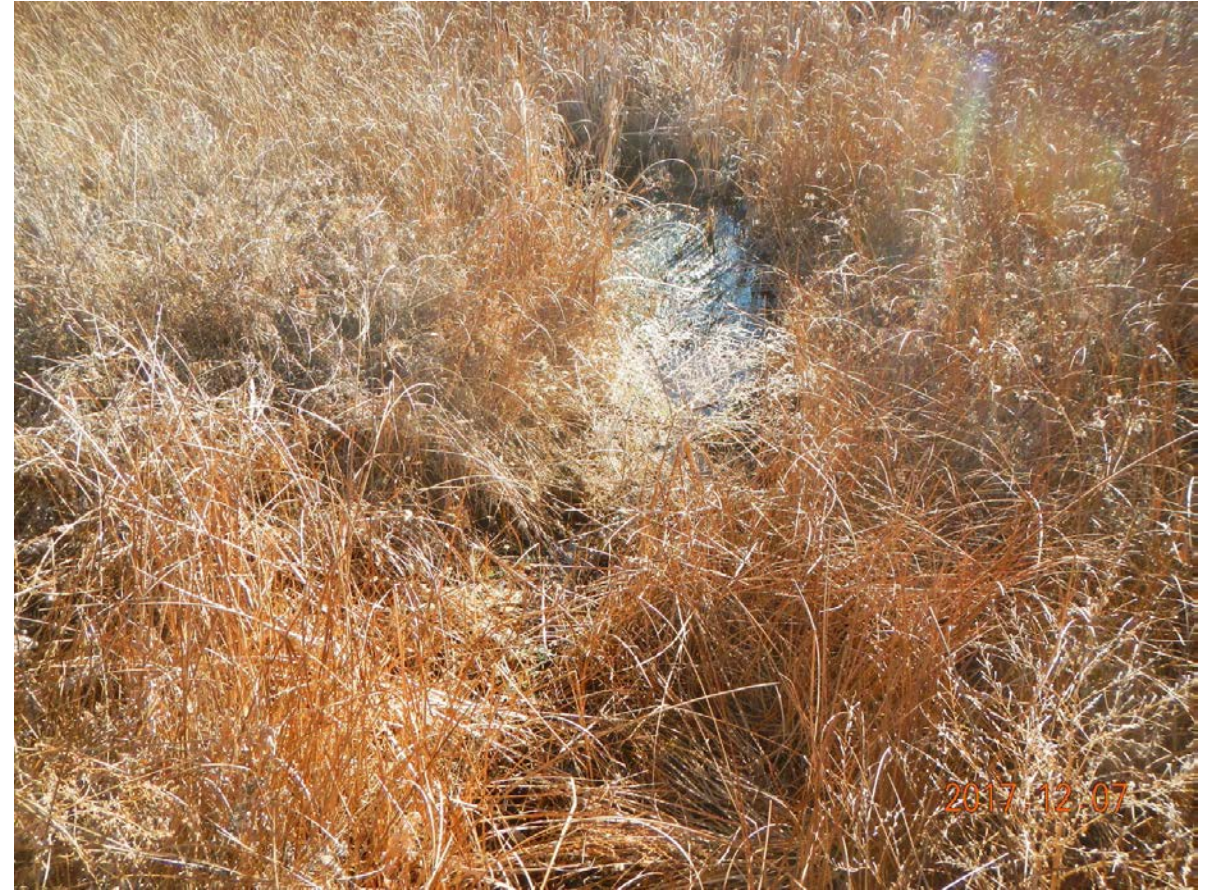
20\_Seepage area left of old outlet
