# ENGINEER'S INSPECTION REPORT

OFFICE OF THE STATE ENGINEER - DIVISION OF WATER RESOURCES - DAM SAFETY BRANCH

DAM NAME: HALE - DWIGHT G T: 150S R: 0650W S: 29 COUNTY: EL PASO DATE OF INSPECTION: 12/7/2017  
DAM ID: 100136 YRComp: 1940 DAM HEIGHT(FT): 13.5 SPILLWAY WIDTH(FT): 82.0 PREVIOUS INSPECTION: 9/28/1987  
CLASS: Low hazard DAM LENGTH(FT): 600.0 SPILLWAY CAPACITY(CFS): 1062.0 NORMAL STORAGE (AF): 6.0  
DIV: 2 WD: 10 CRESTWIDTH(FT): 10.0 FREEBOARD (FT): 4.0 SURFACE AREA(AC): 2.0  
EAP: Not Required CRESTELEV(FT): 5600.0 DRAINAGE AREA (AC.): 1050.0 OUTLET INSPECTED:

Hale Dam  
DAMID 100136  
Inspection Photos

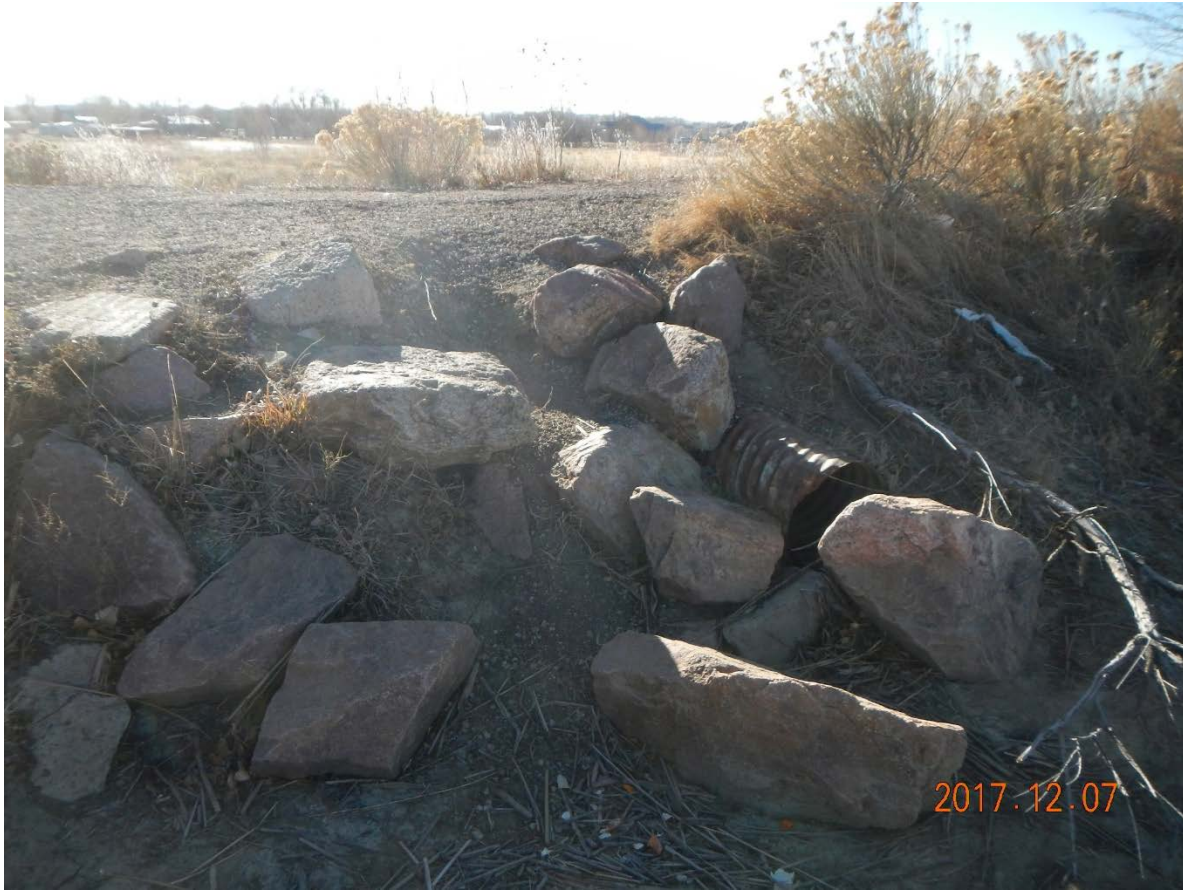
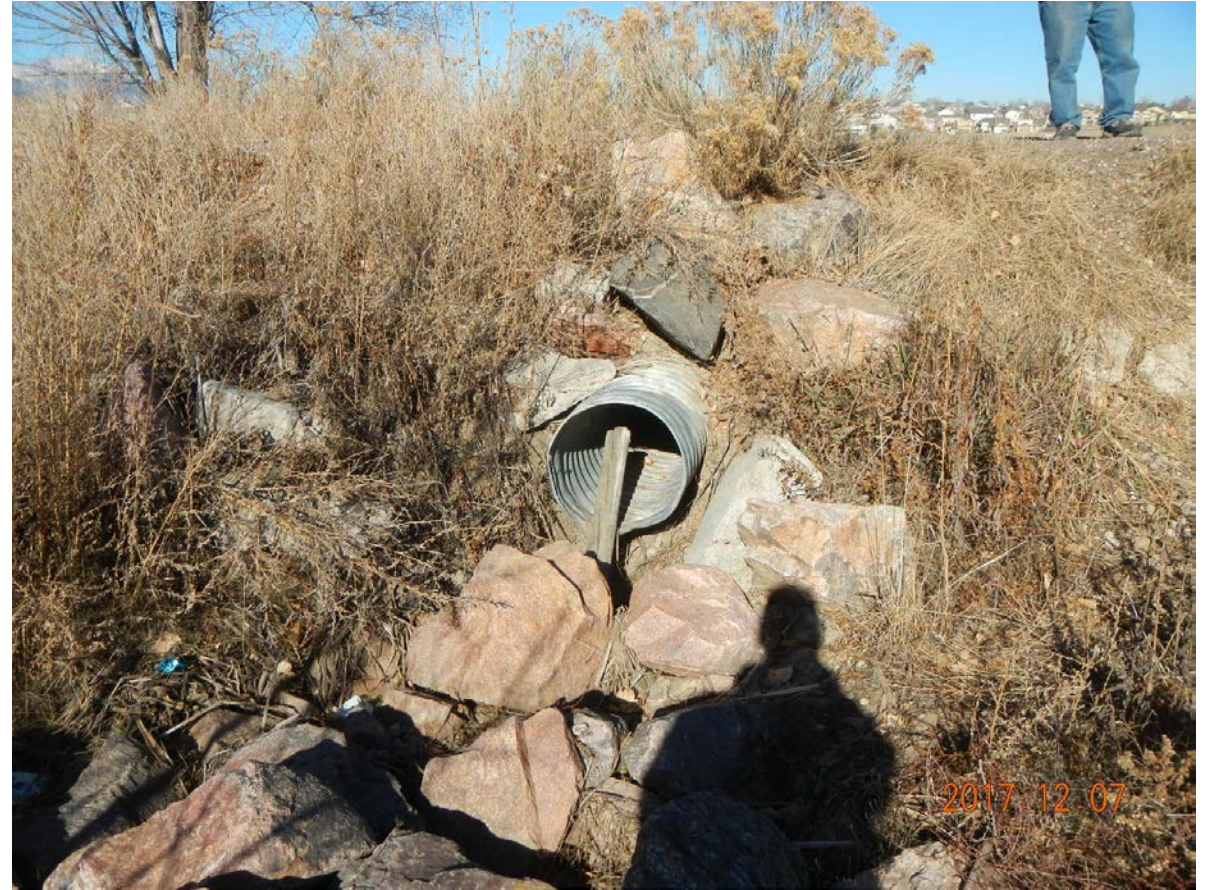
There is an 18-inch CMP located near the left abutment that is slightly higher in elevation it appears that the emergency spillway channel located on the right abutment. The emergency spillway has significant headcutting about 40-ft below the spillway crest. The headcutting is about 4.5-ft deep in sandy soils and about 20-ft wide.

21\_Pipe Spillway on left end of dam

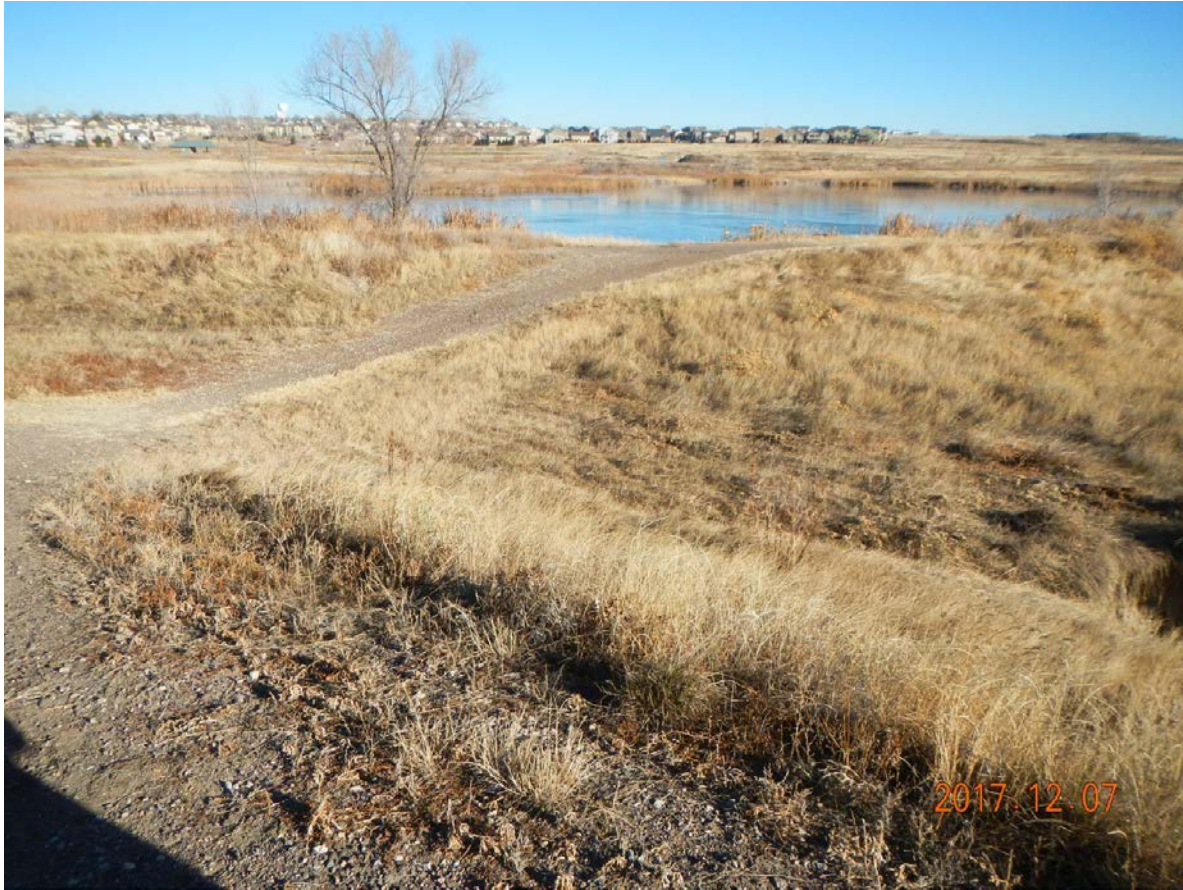
23\_Em Spwy crest

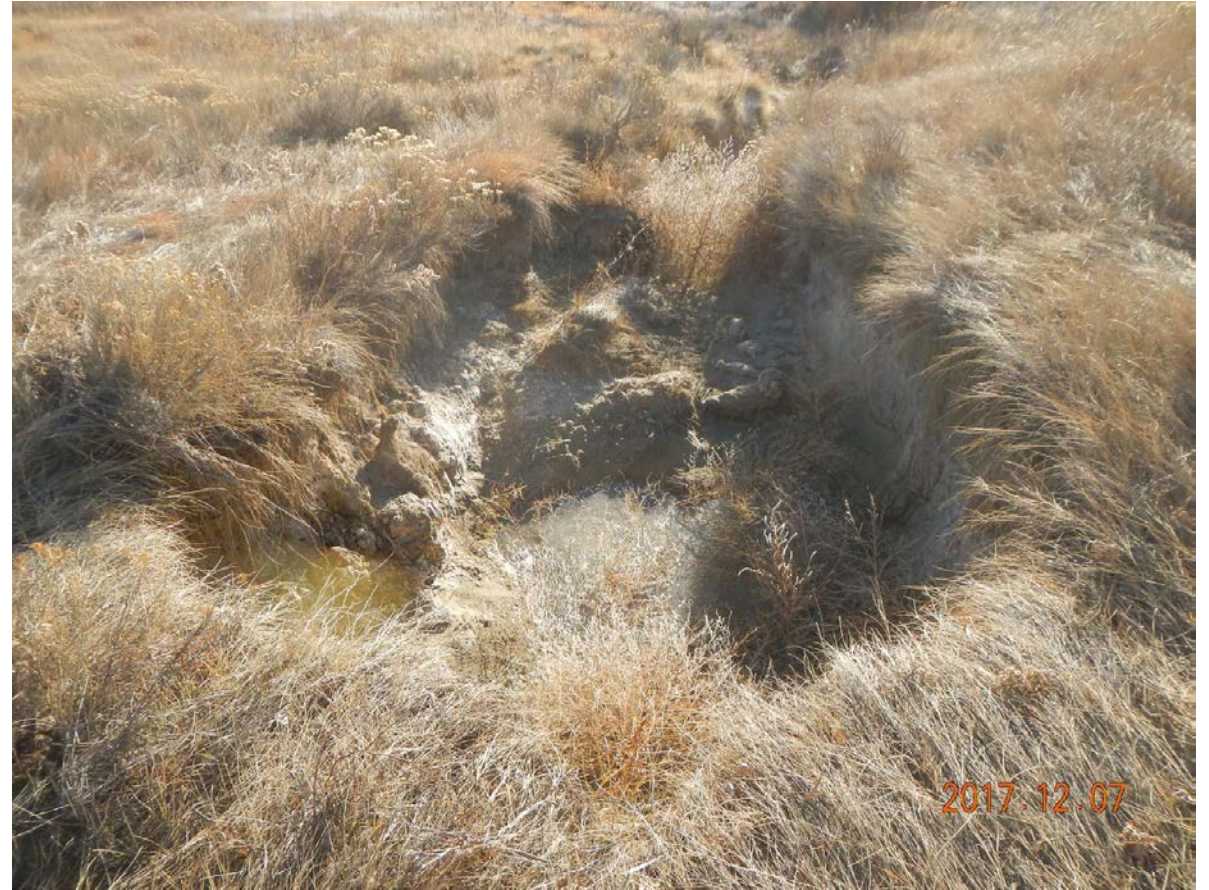
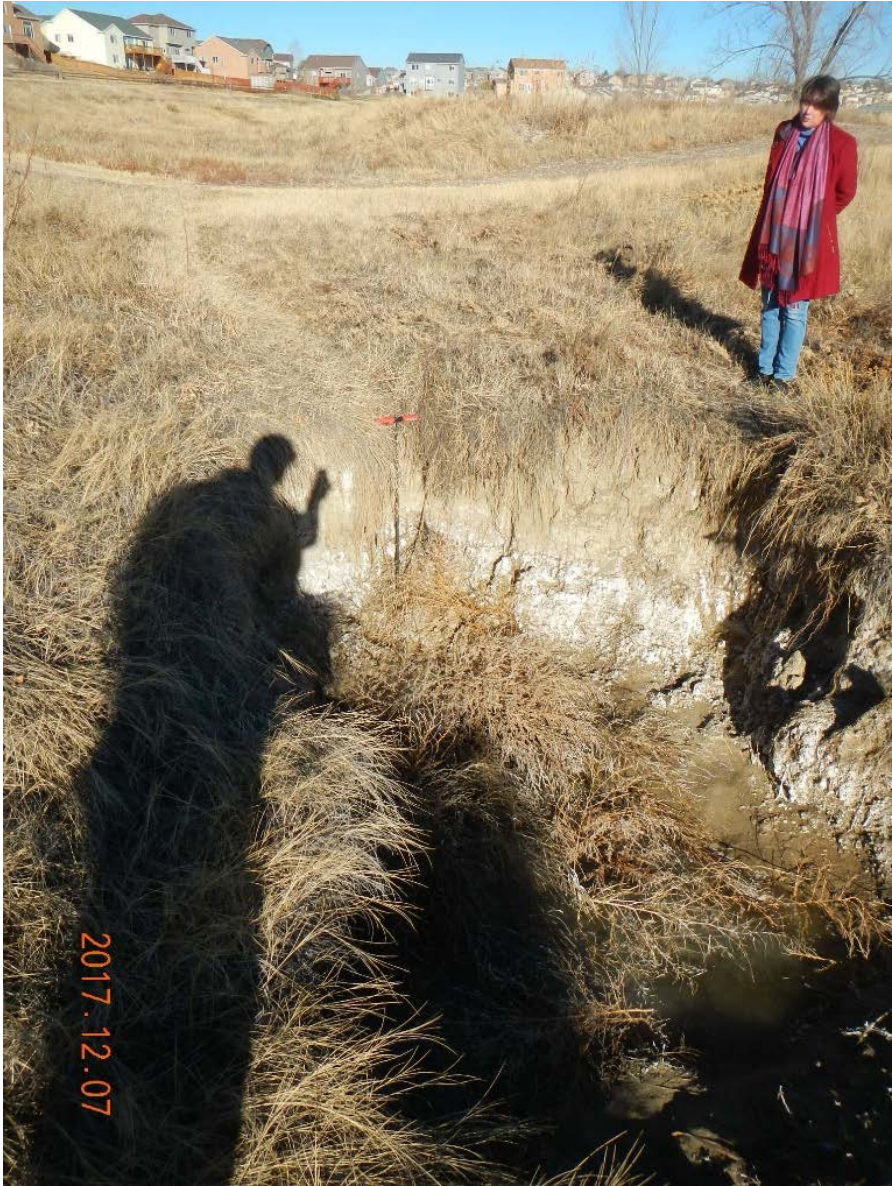
24\_Em Spwy headcutting

This headcutting should be repaired during the interim period to new dam construction, given the proven likelihood of storm events creating flow through the spillway in recent years. The slopes of the headcut area should be sloped back and allow for new fill to be properly compacted in thin lifts up to the spillway channel grade. The surface of the area should be protected with riprap as an armor protection measure.

**The primary maintenance required is to repair the emergency spillway channel headcut as described above.**
